**REPORT NUMBER: RED-08-02**

**REPORT ON EARLY DISTRESS (RED)**

**Investigation of PCC Pavement on STH 29**

**FINAL REPORT**

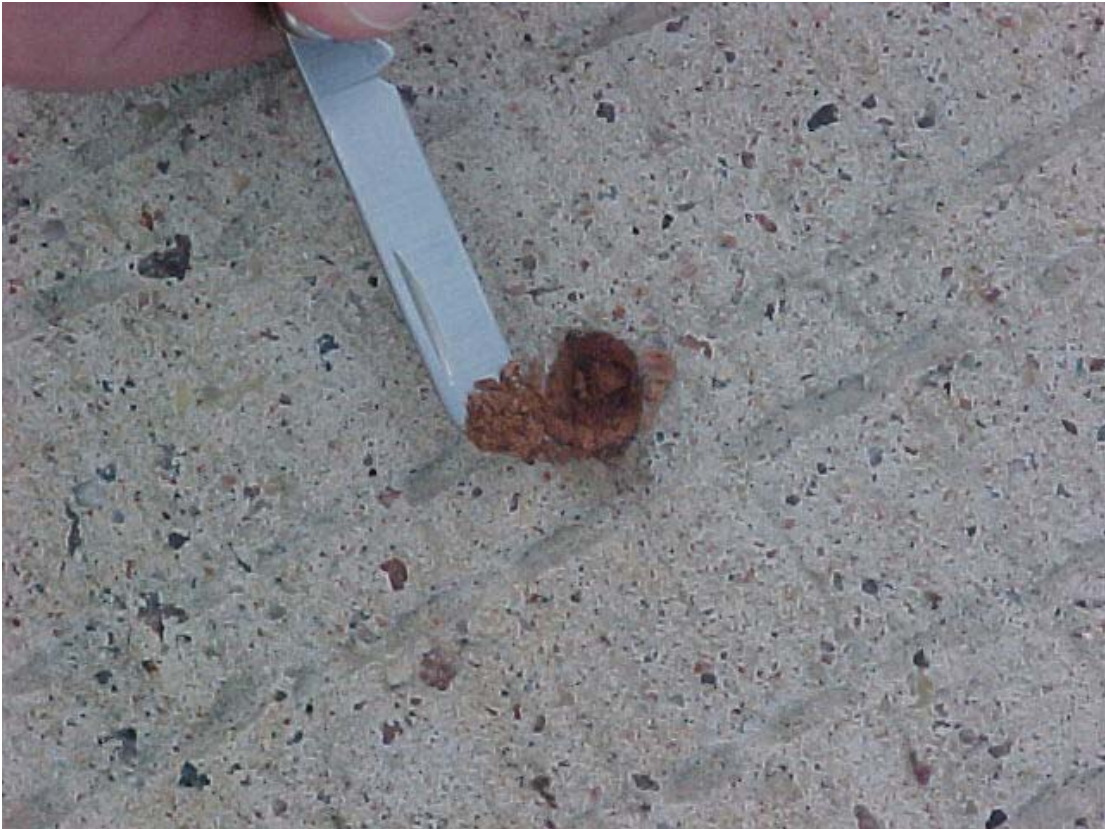
Print 1. Example of the numerous unmixed clay deposits.

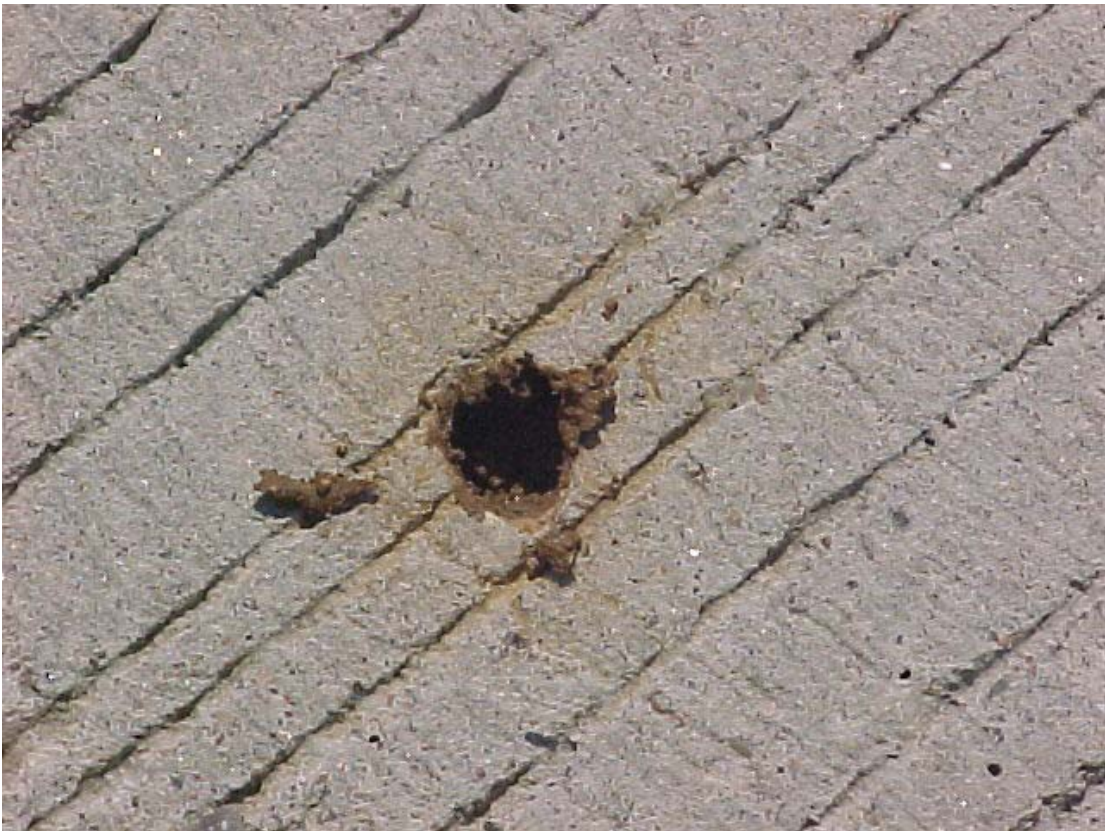
Print 2. Another view of a pocket of clay.

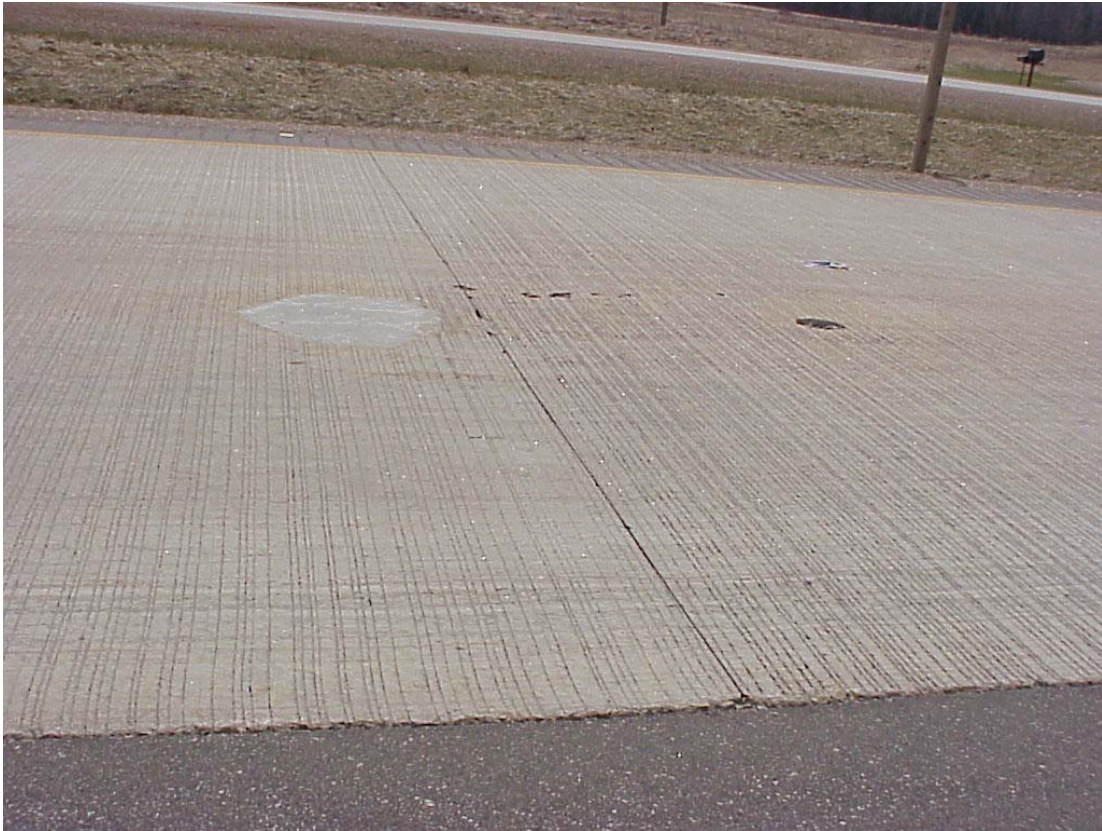
Print 3. A partial depth repair of a delaminated section. A brownish discoloration of the PCC is evident.

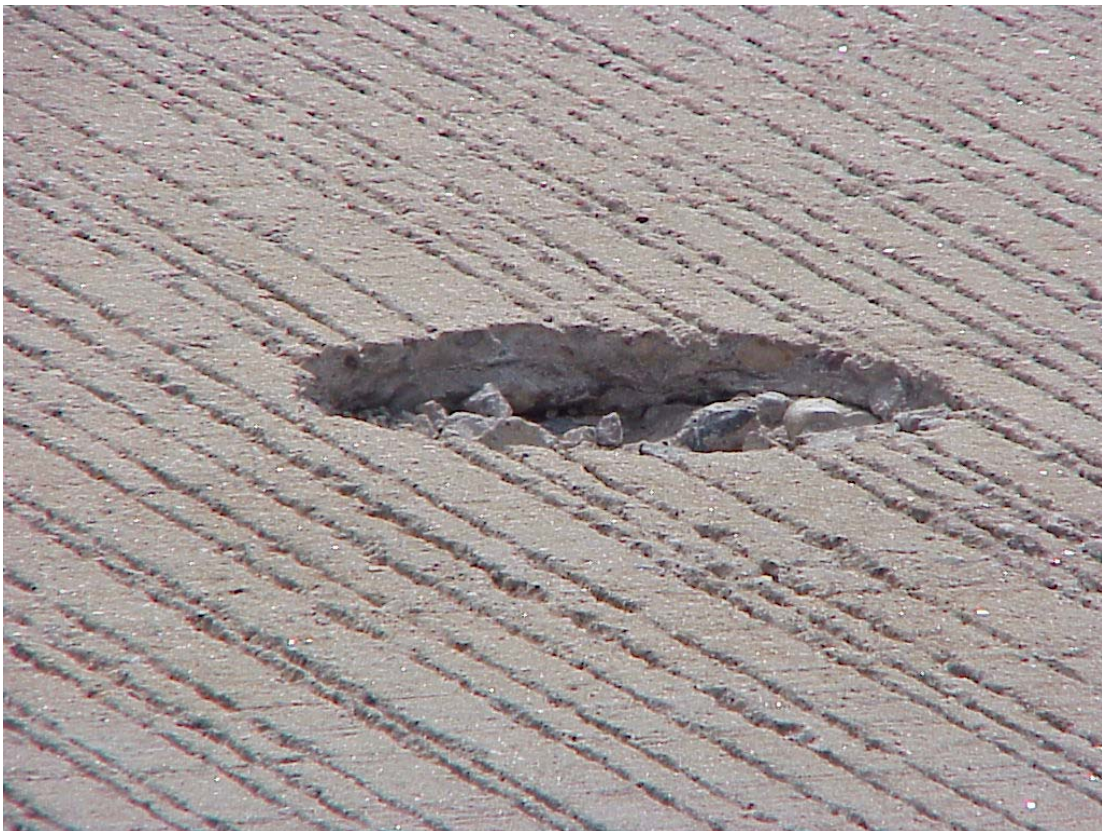
Print 4. A punch-down caused by poor mixing and resulting voids.

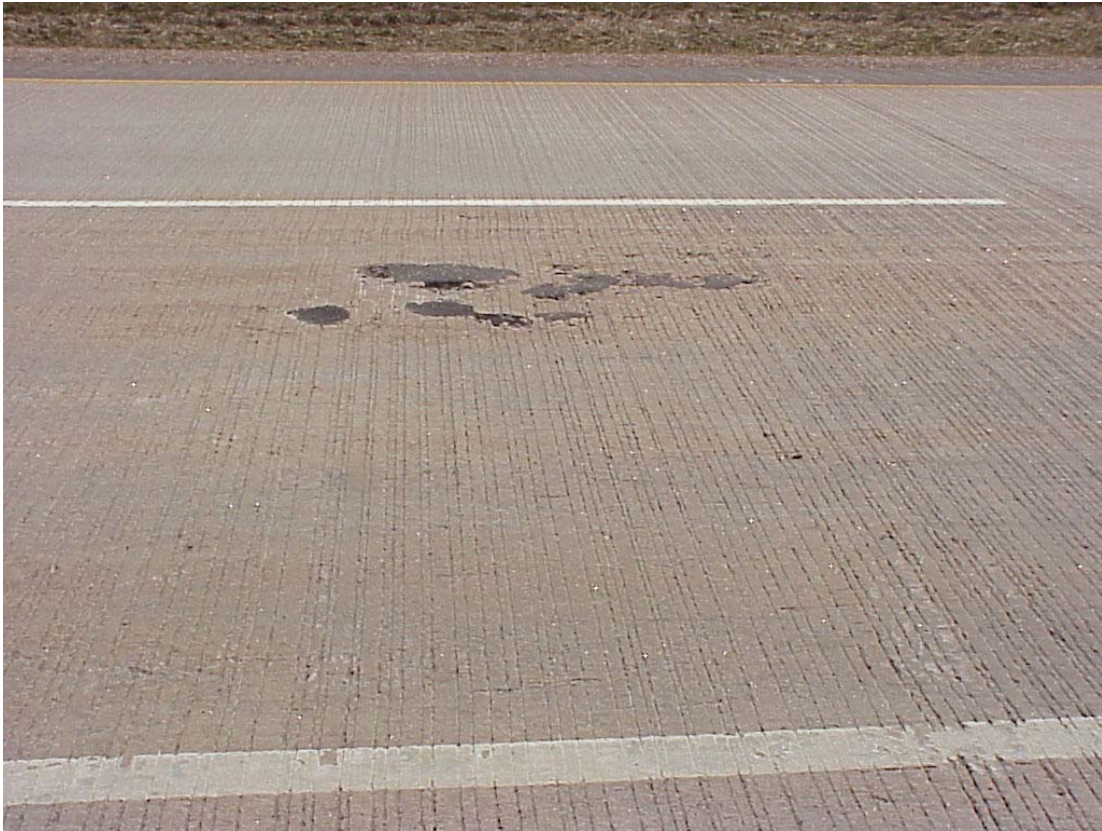
Print 5. Notice the brownish discoloration of the PCC pavement in this area of repairs.

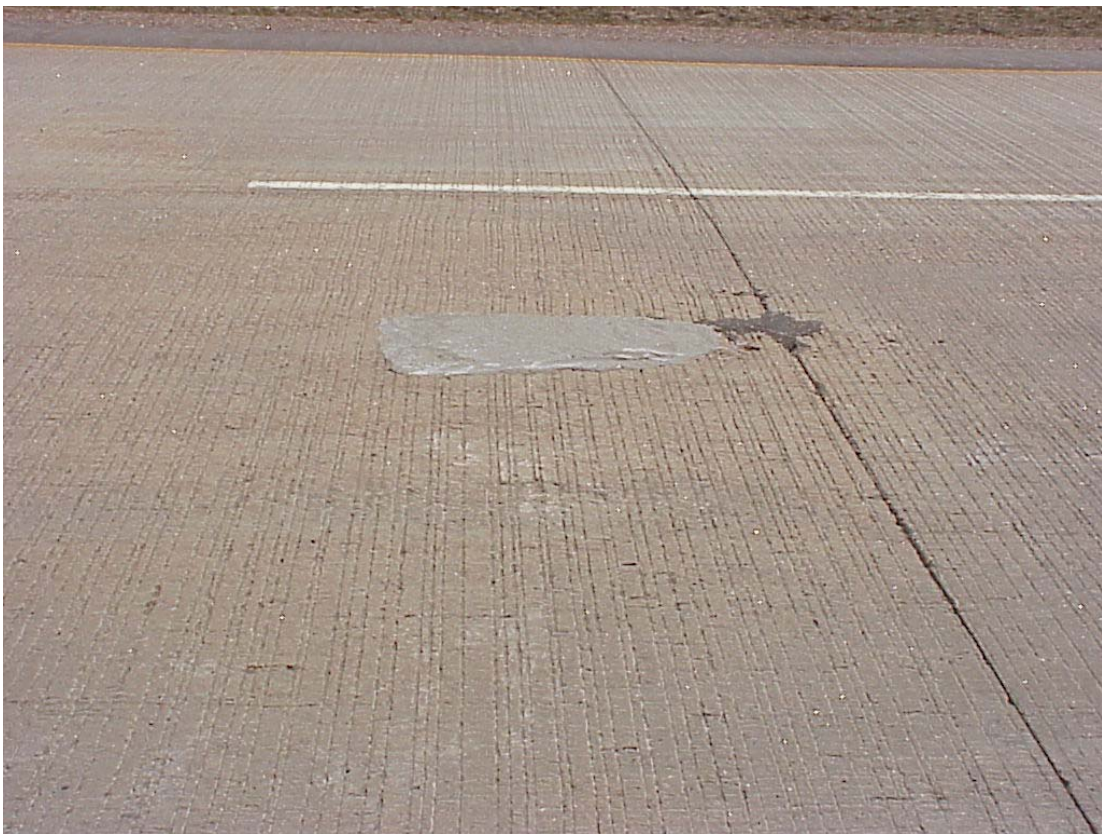
Print 6. Again, notice the brownish discoloration of the PCC pavement in this area of repairs.

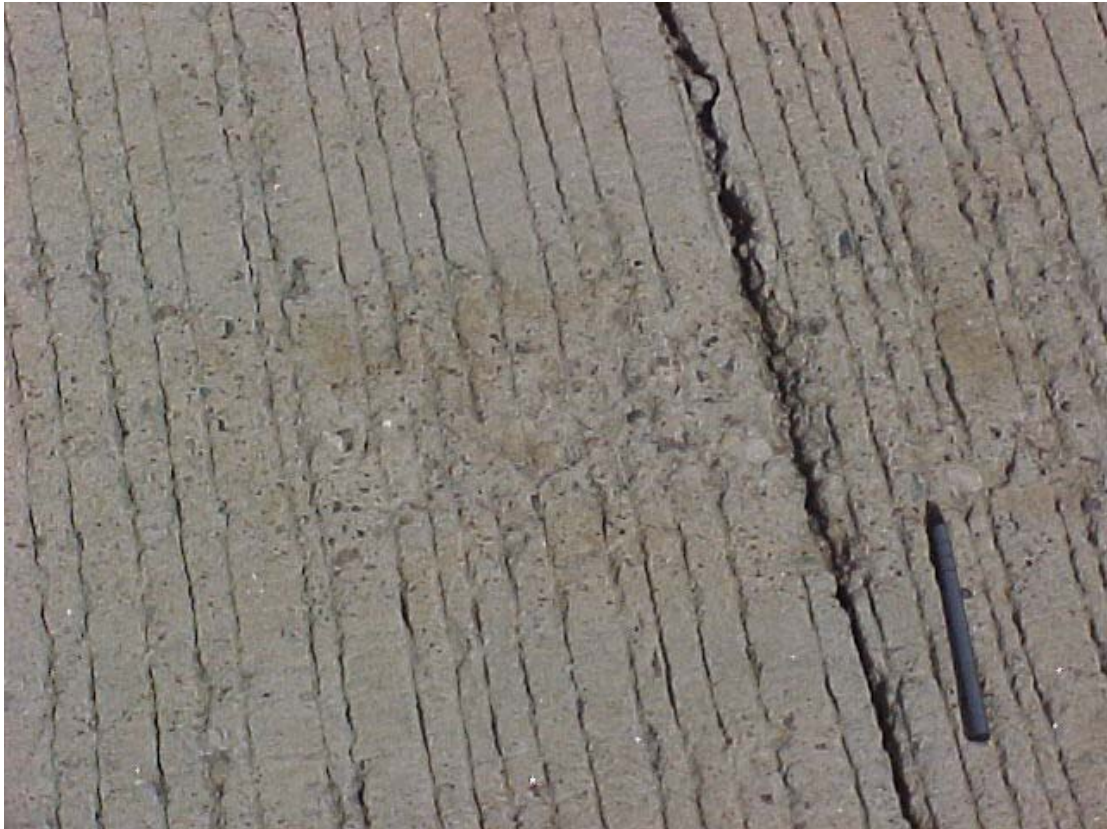
Print 7. The pavement here is deteriorating from the top down.

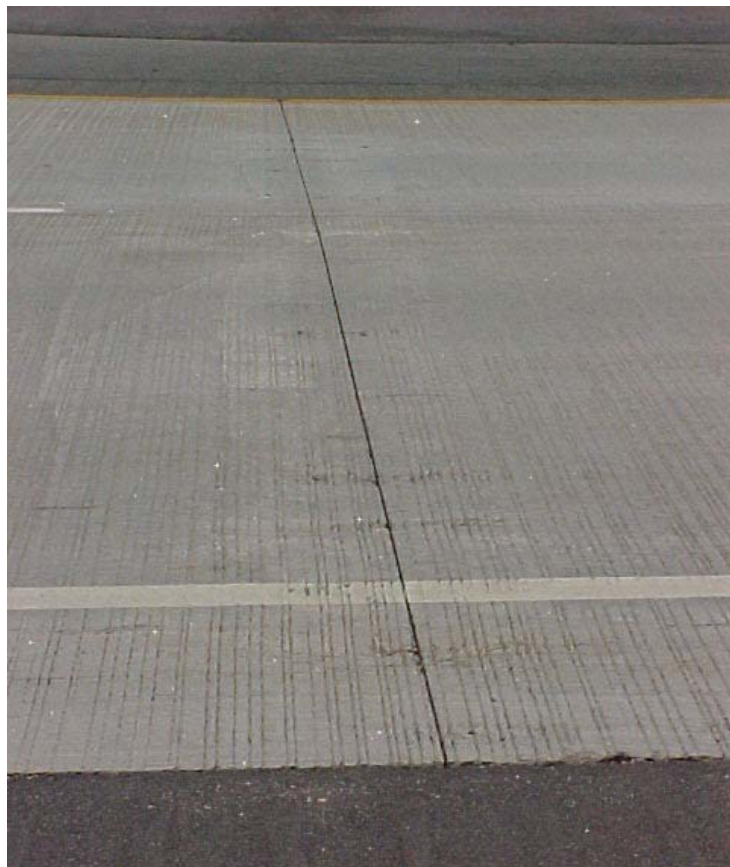
Print 8. The locations of the dowel bars are visible from the surface.

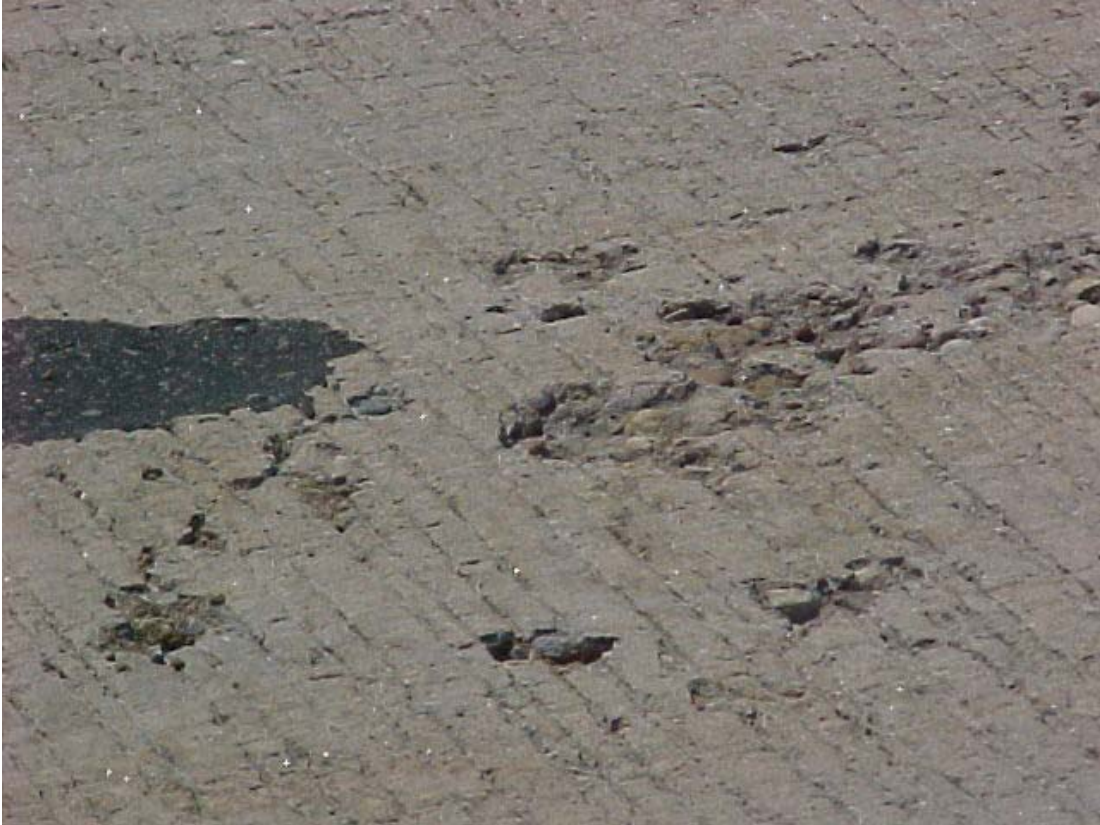
Print 9. A close-up view of poorly mixed concrete.

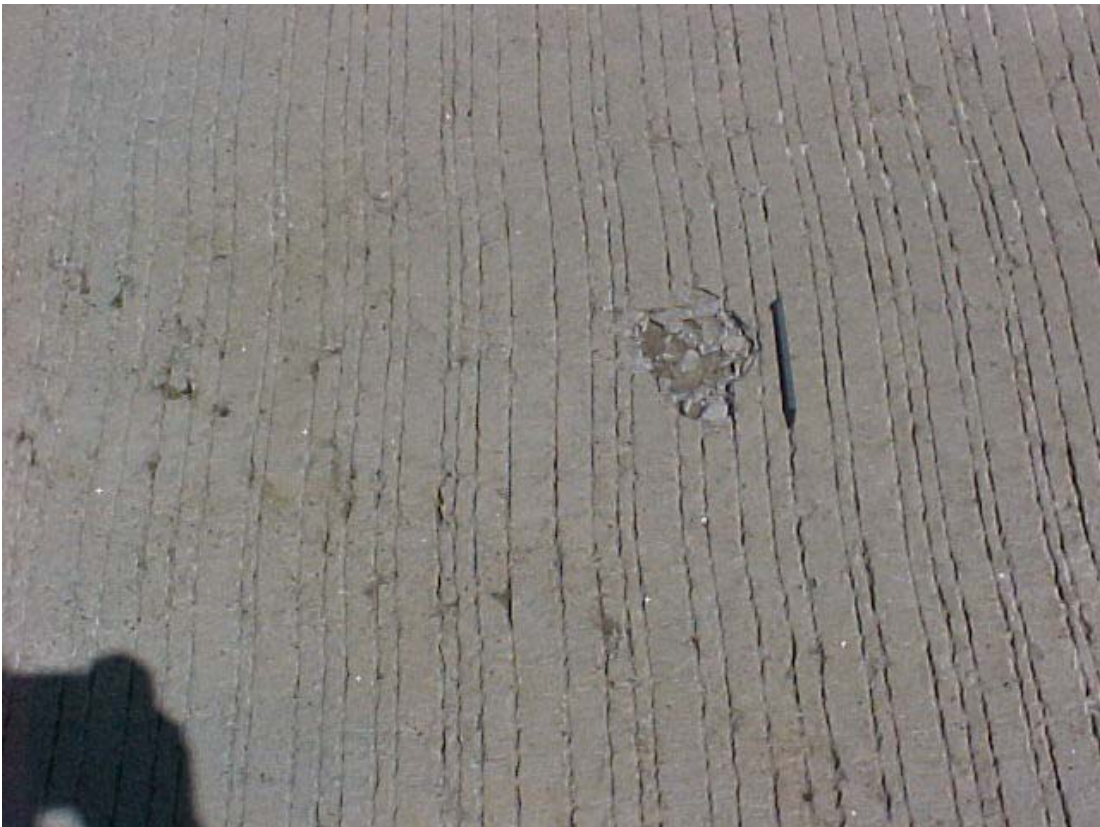
Print 10. A view of a type of early distress for this pavement based on poor mixing.

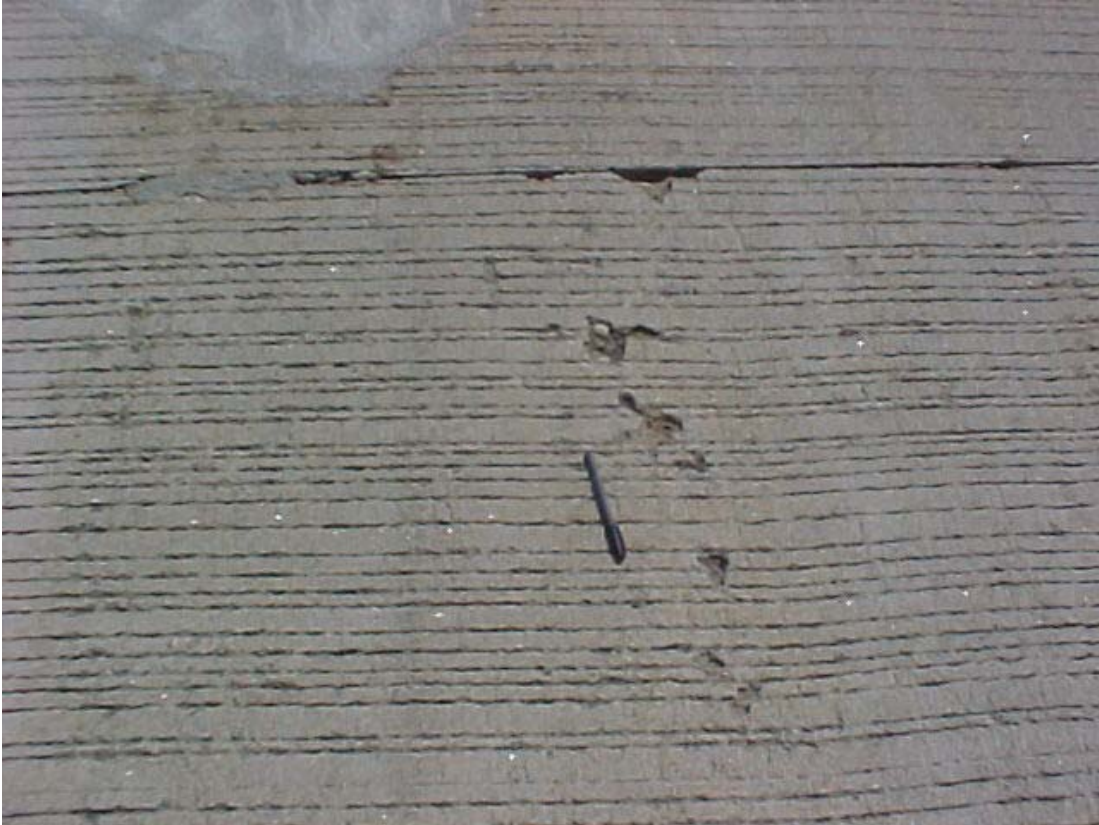
Print 11. Another view of the “typical” early distress occurring on this project.

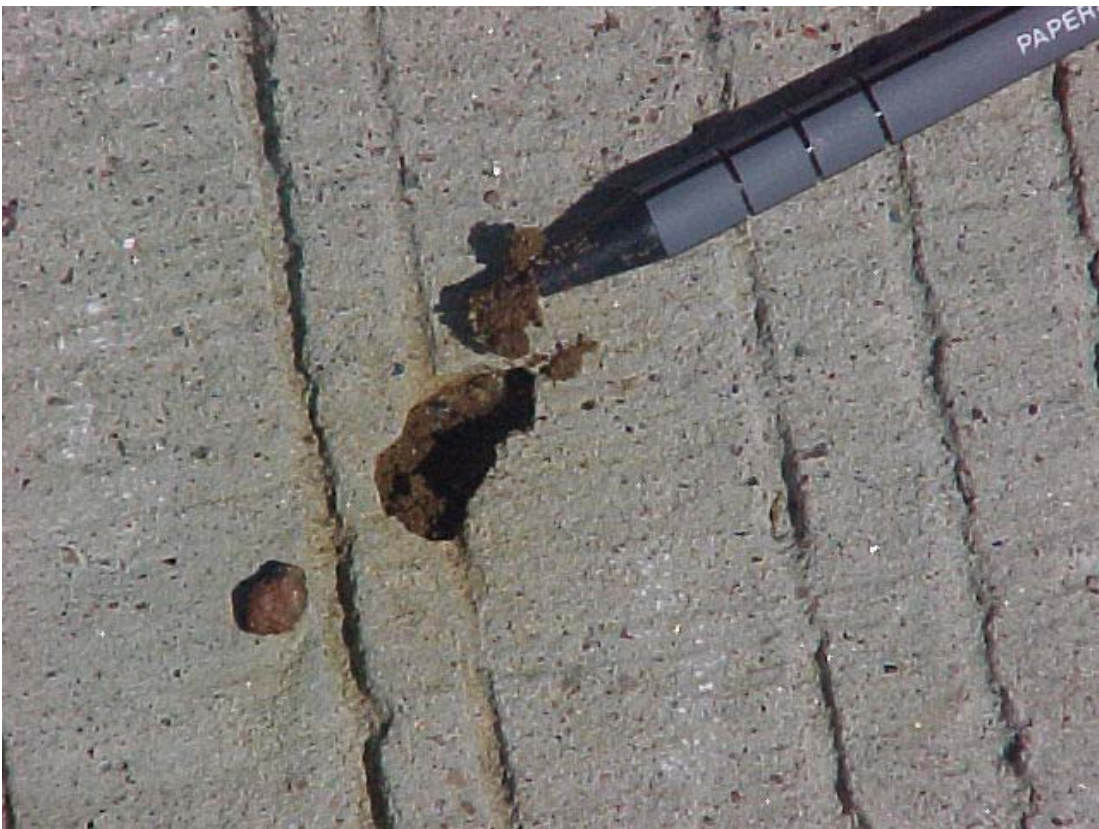
Print 12. Notice how the clay deposit is sticking to the end of the pen and the void in the pavement.

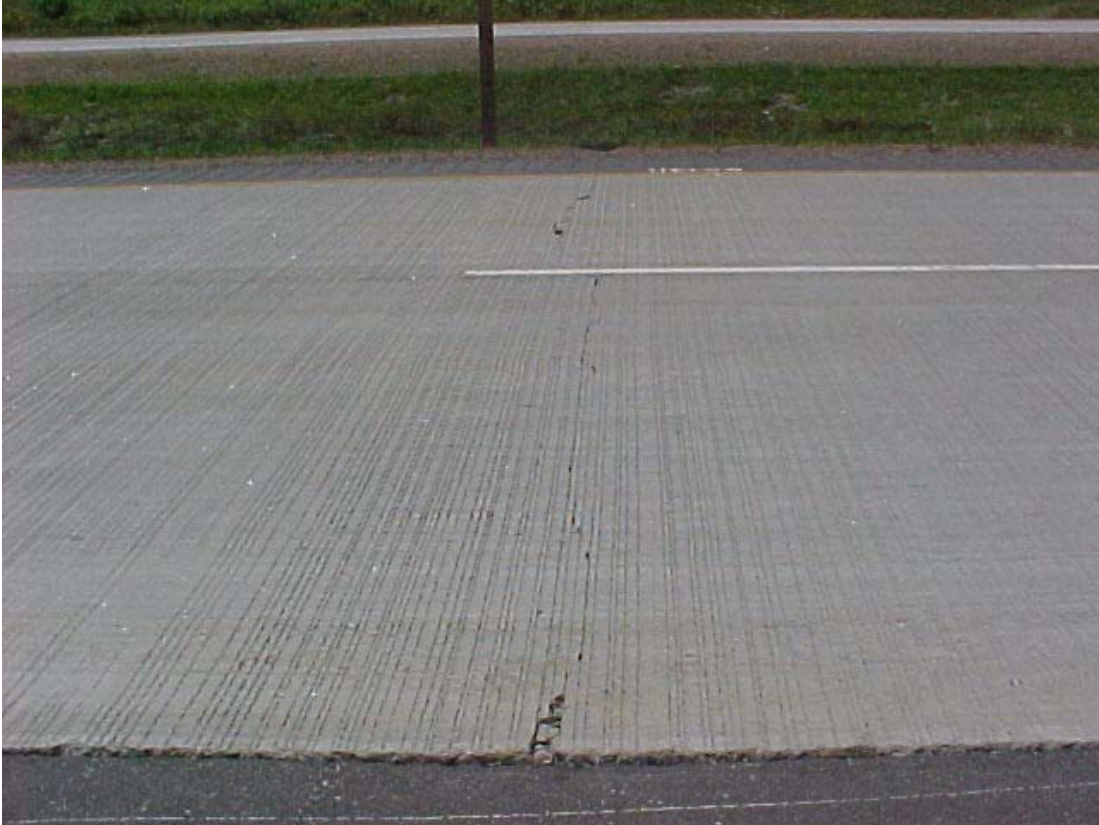
Print 13. Example of a mid-panel crack.

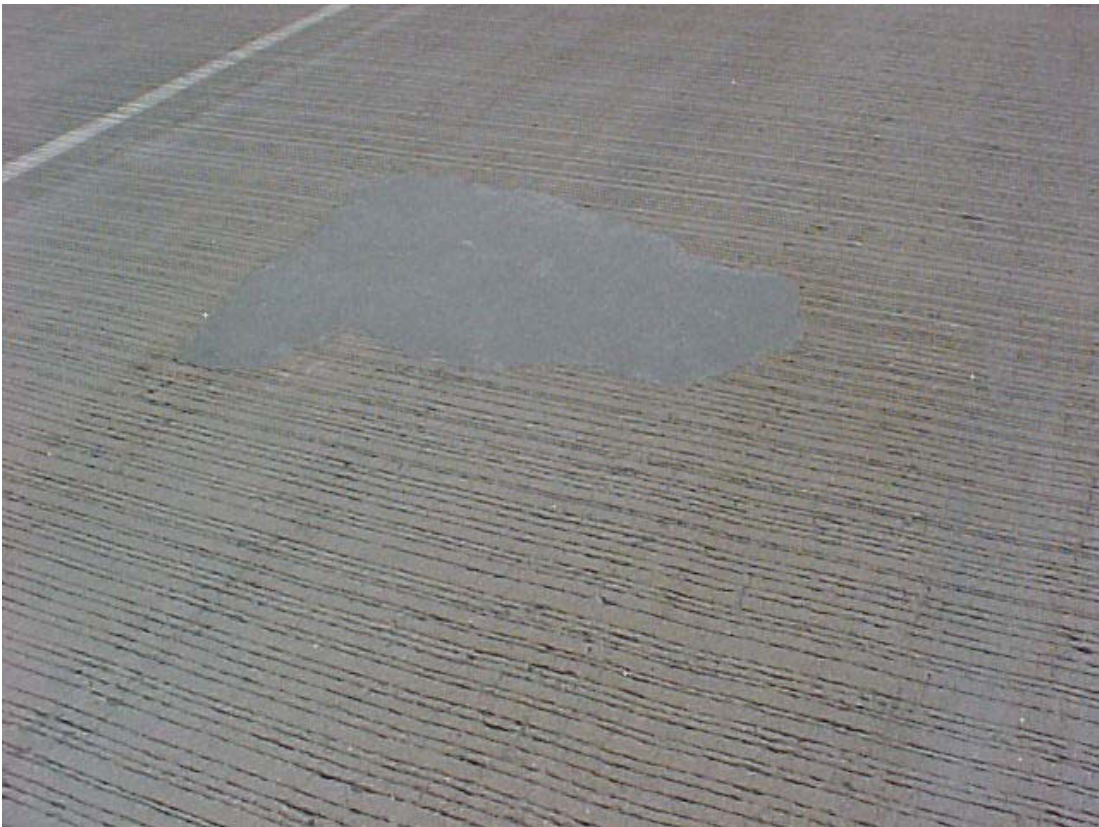
Print 14. Notice the brownish tint to the pavement in the vicinity of the patch.

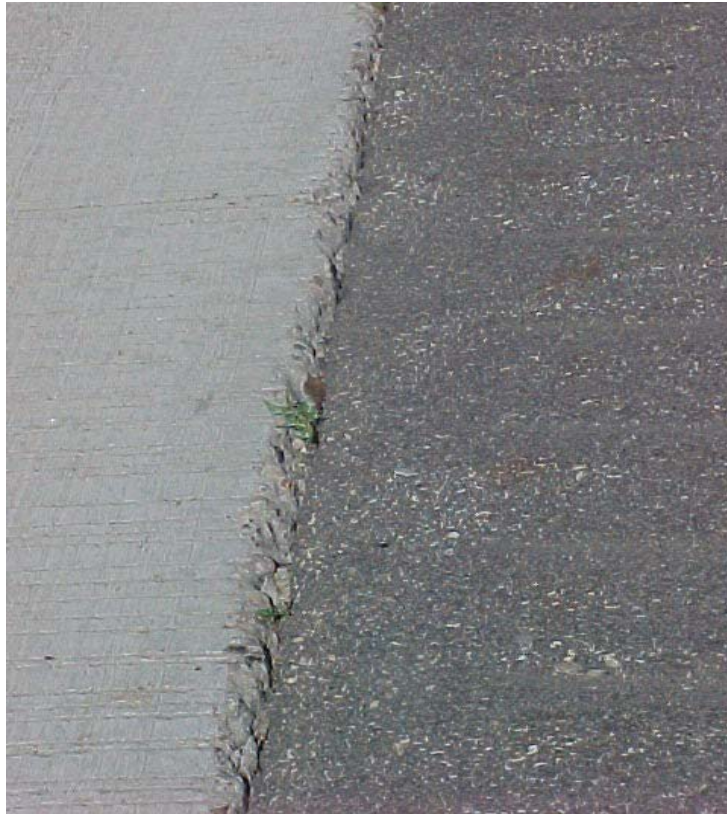
Print 15. View of the raveled edge distress prevalent on the project.

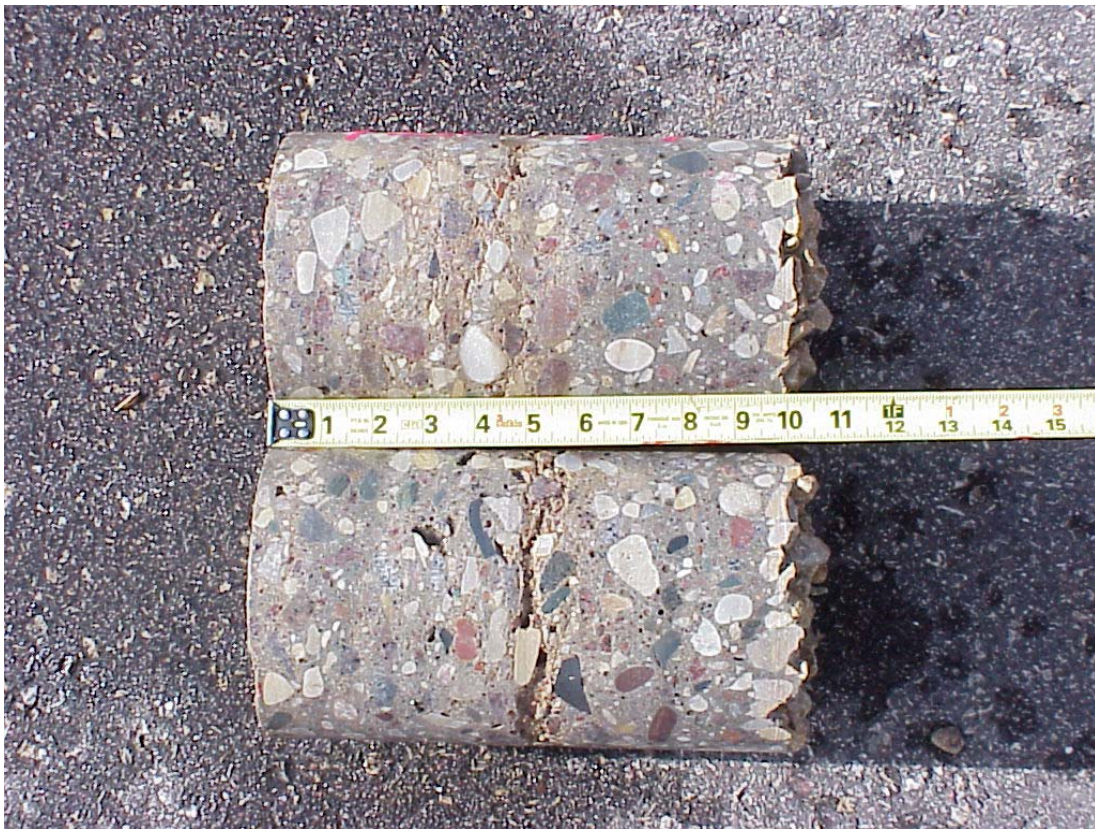
Print 16. Example of the sand layering found throughout the project. Water from the coring operation disintegrated the sandy layer at mid-core depth as shown above.

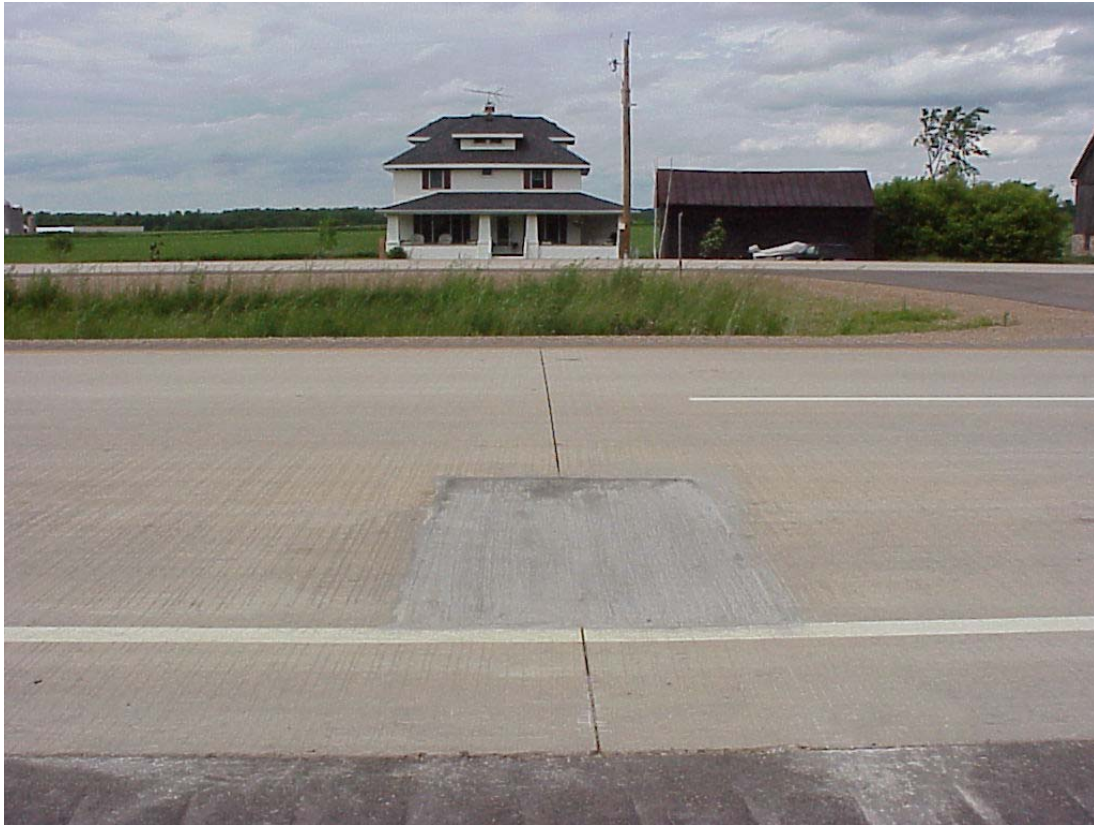
Visual surface distress as described in the beginning of this report is evidence of poor concrete quality for the days paved in May being proposed for replacement without freeze/thaw or petrographic evidence (see Table 3 below). In fact, a June, 2002 field survey found that the brownish tint to the pavement surface noticed in various areas was a precursor to more serious deterioration of the pavement (see photos 17-18 in Appendix B on page 24).

Print 17. Example of a patch, photo taken 6-15-00. Patch is located at station 68+383 EB.

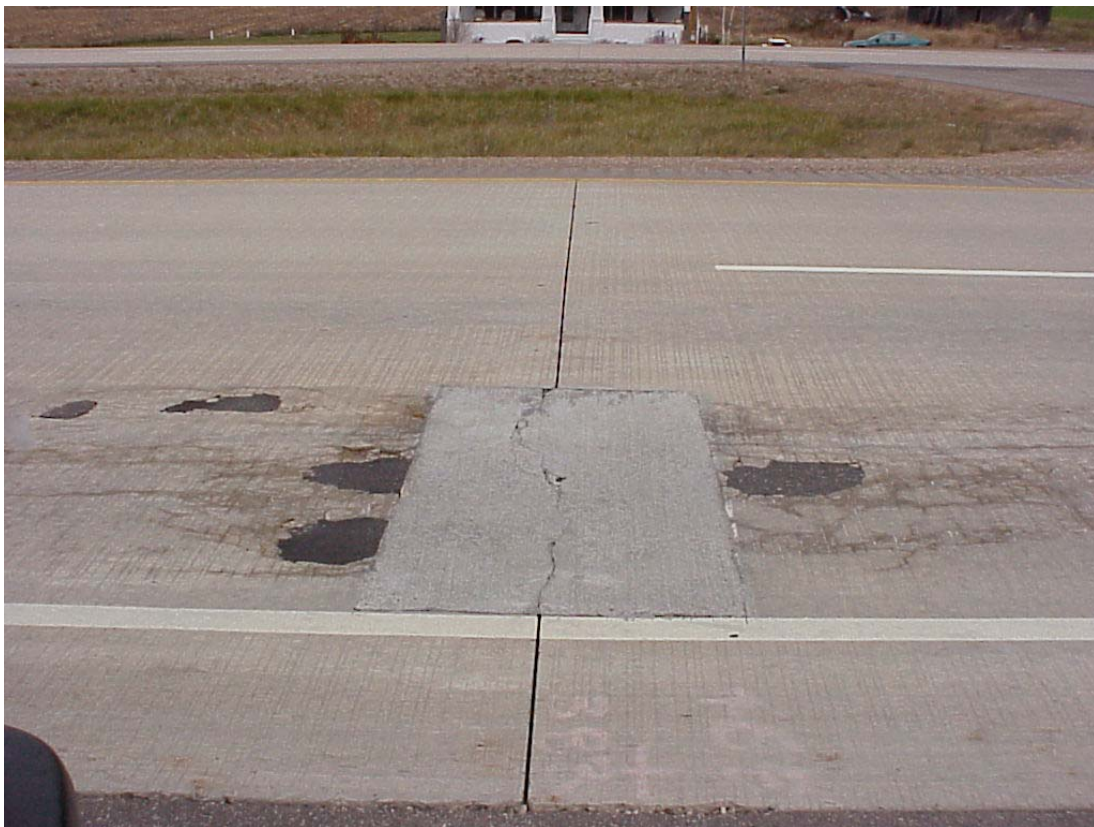
Print 18. A view of the same patch above, taken 11-8-01, a little more than 1 year after above photo.

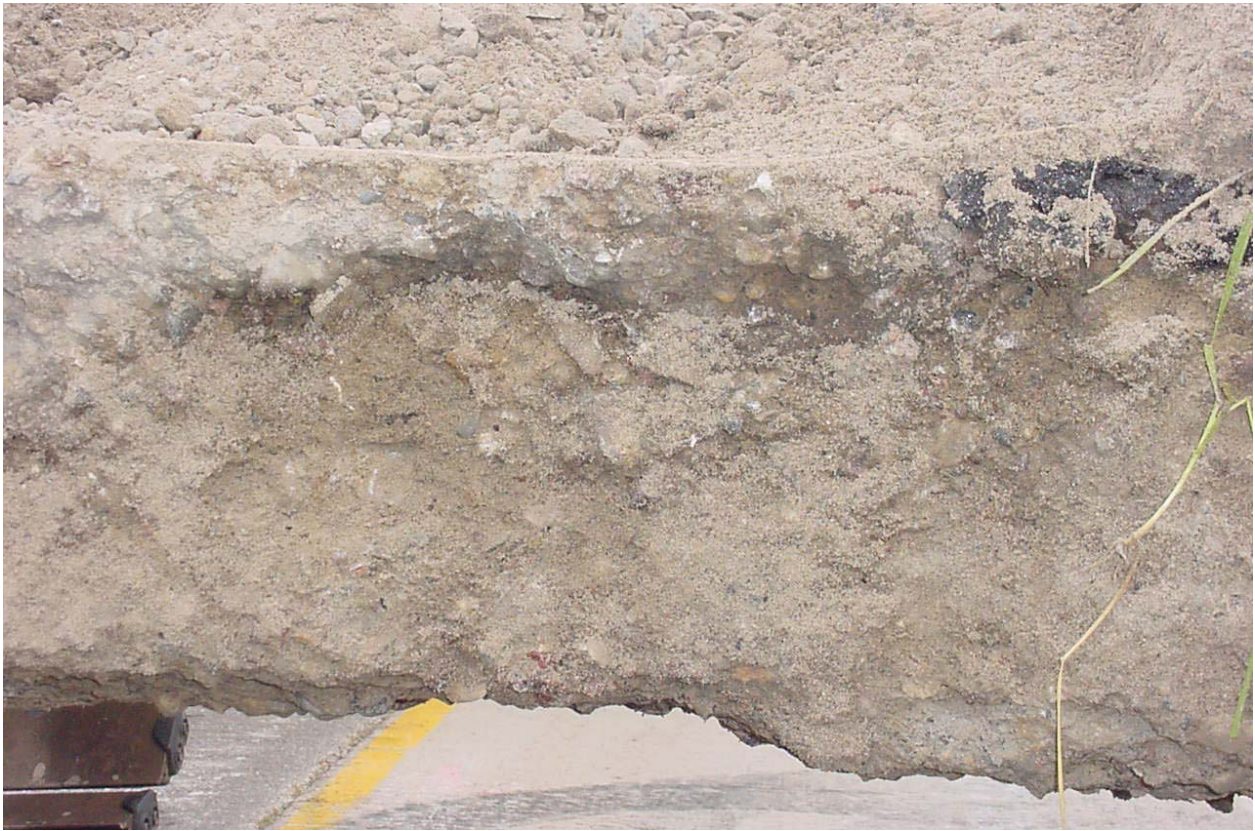
Print 21. View of a slab cross-section that was replaced in August 2002.

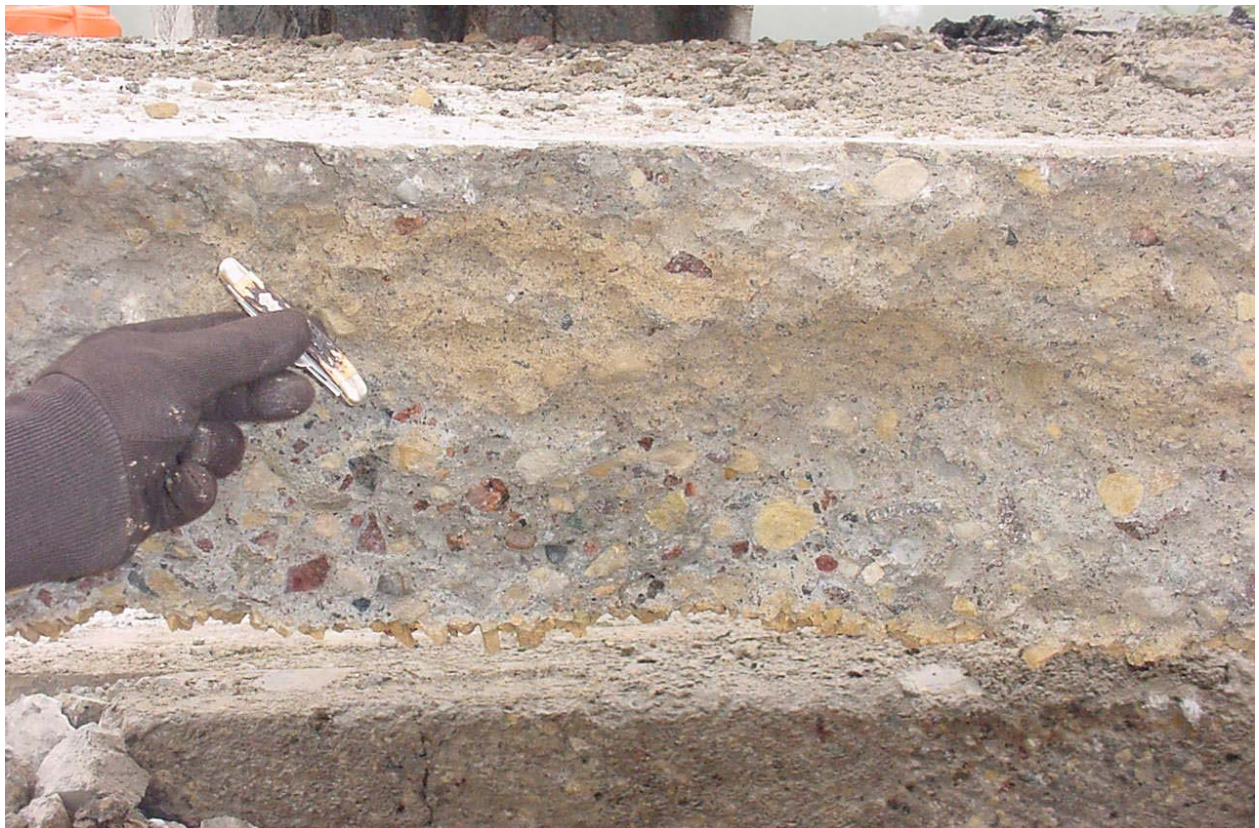
Print 24. Another slab that was replaced in August 2002. Notice the sand layer.

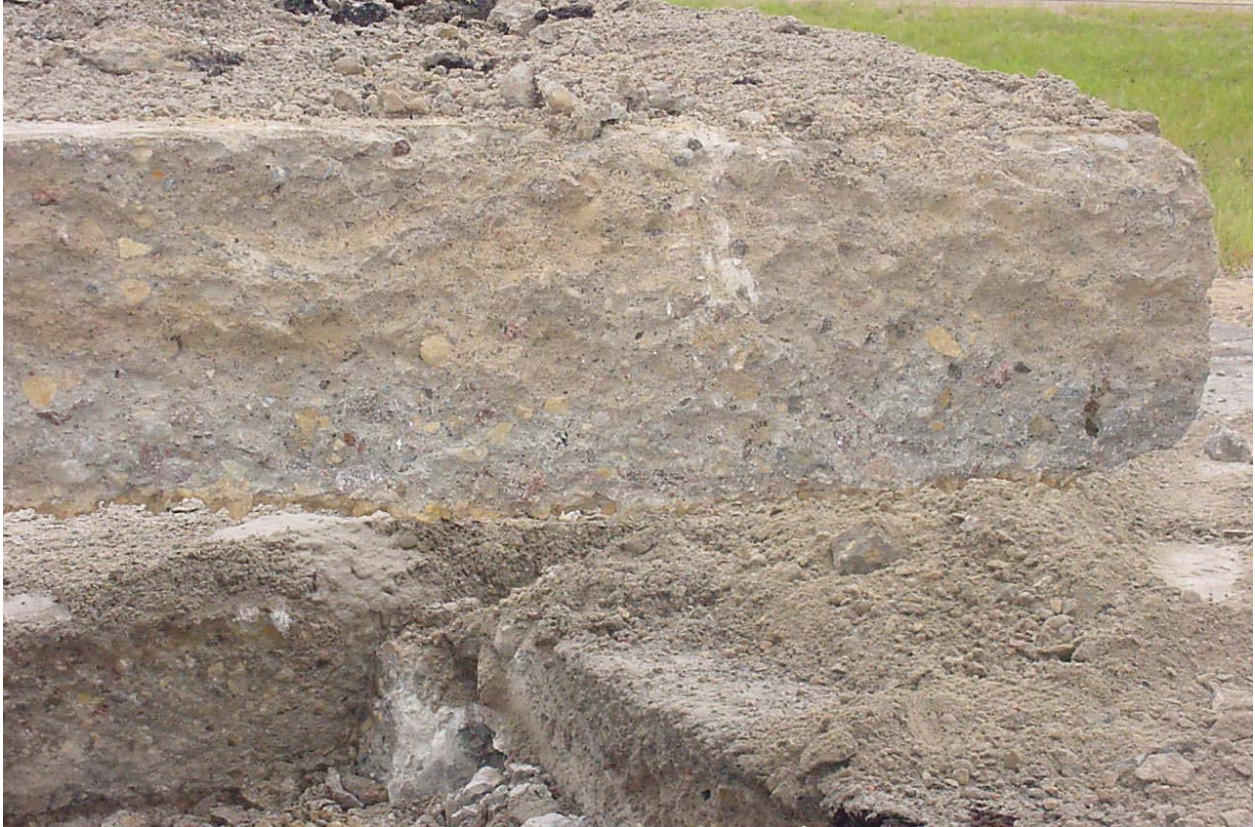
Print 25. Another slab with the distinct sand layer, this was replaced in August 2002.

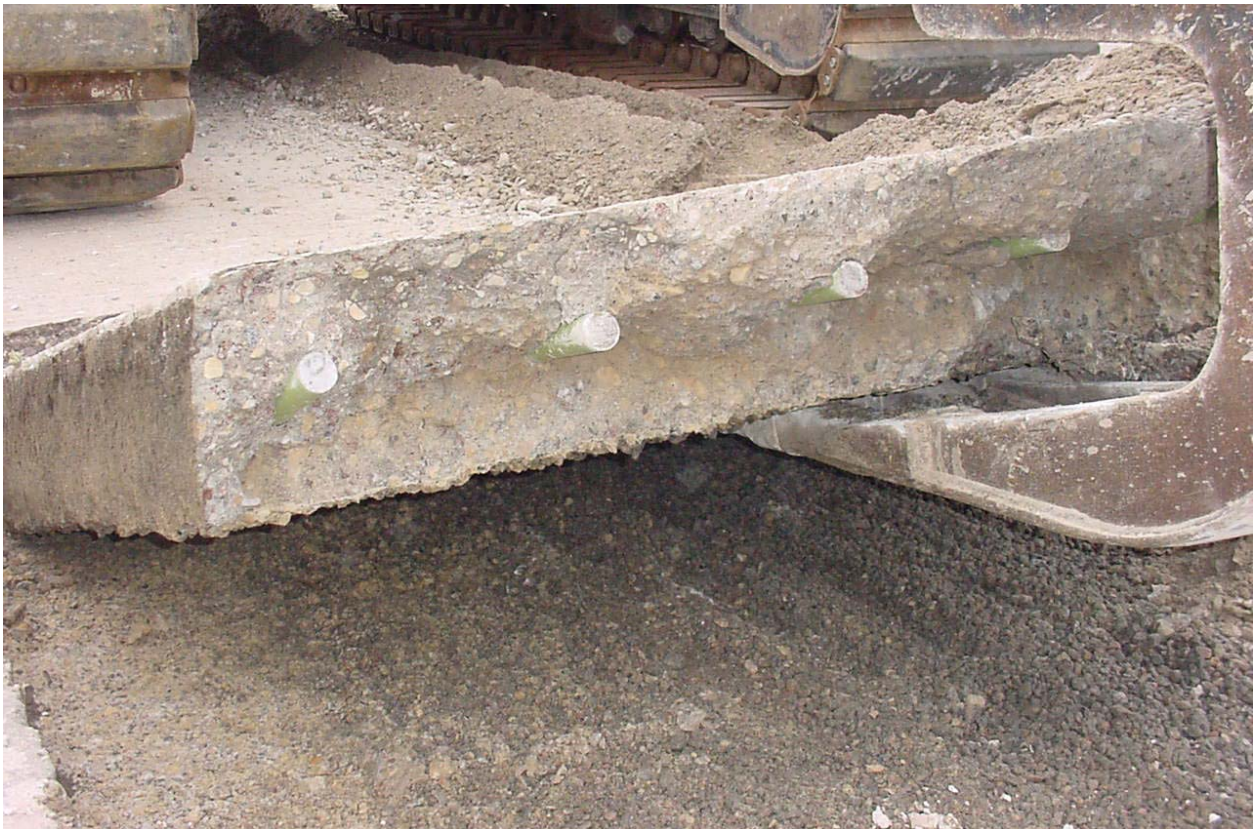
Print 26. The sand layer, in this case, runs near the bottom and mid-portion of the slab.

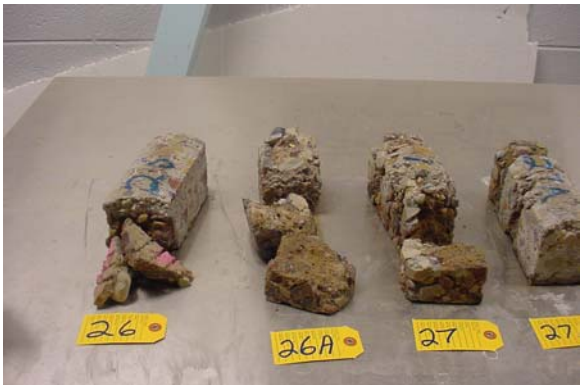
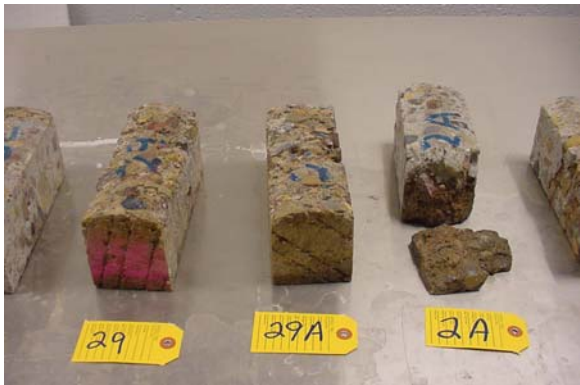
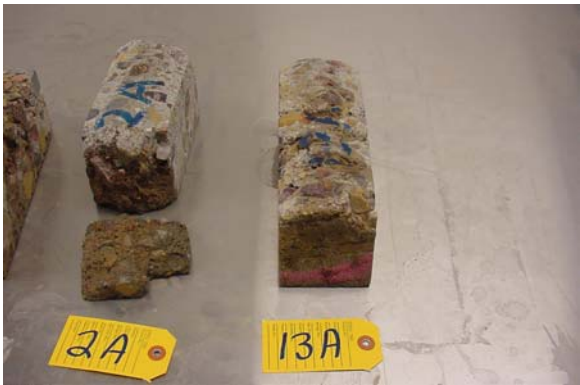
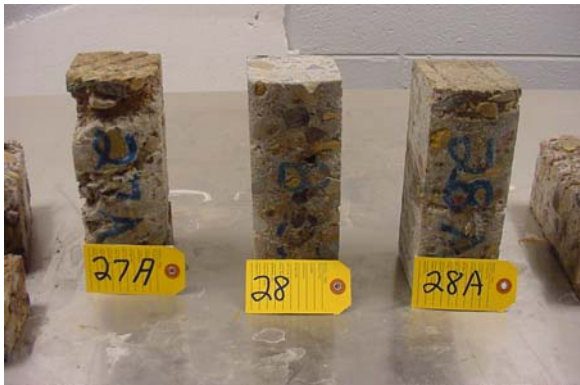
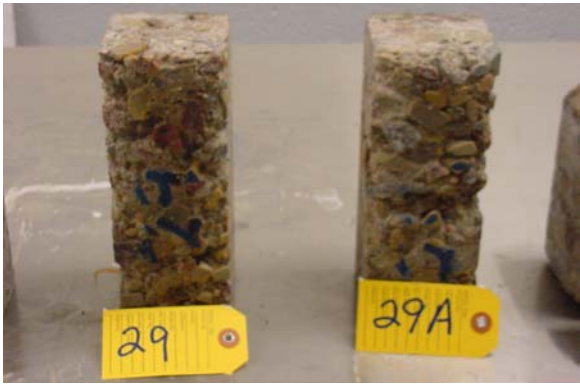
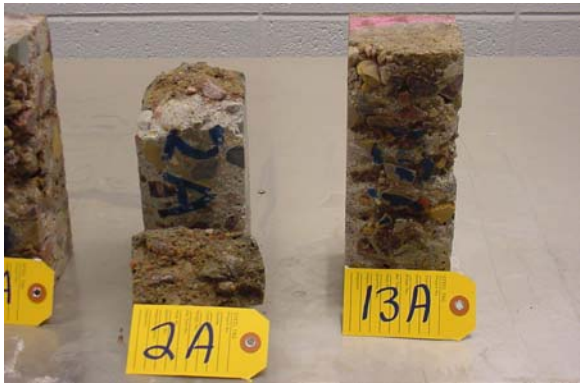
Prints 29-36. Freeze-thaw durability test results after 302 lab freeze-thaw cycles.

Five of the ten cores (2A, 26, 26A, 27, 27A) from the final coring set failed the freeze/thaw durability test while a sixth core (29A) was borderline in terms of pass/fail. The cores corresponded to paving on May 12<sup>th</sup> and May 17<sup>th</sup>, paving days 6 and 8 respectively. Three of the cores (2A, 26, 26A) actually fell apart and split through sand layers in the cores during the test. Table 2 on the following page, contains the freeze/thaw durability test results for the last set of cores that were tested. Freeze/thaw testing for durability was performed as per Method A of ASTM C666. As a frame of reference, good quality concrete typically experiences about 2% section loss when subjected to the freeze/thaw durability test after 300 cycles. Pictures of the concrete specimens subjected to the freeze/thaw durability test can be found at the end of Appendix B.

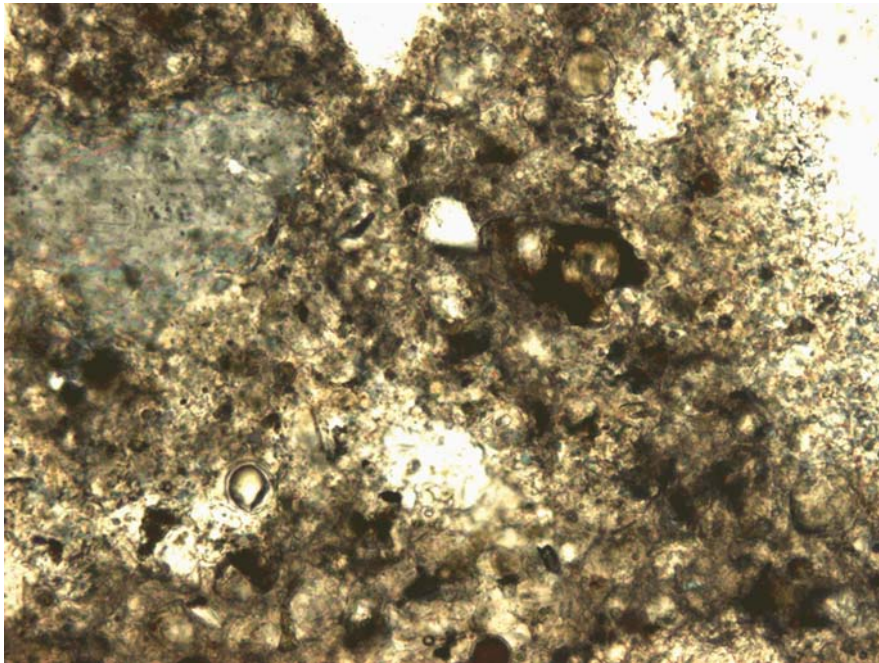
Figure 2a. Cement paste was reasonably hydrated, and unhydrated cement particles were present in the paste. This picture was taken from a thin section of core 2B. Width of field 0.33mm.
